# Kingsdown Seawall Repairs

## Dover District Council

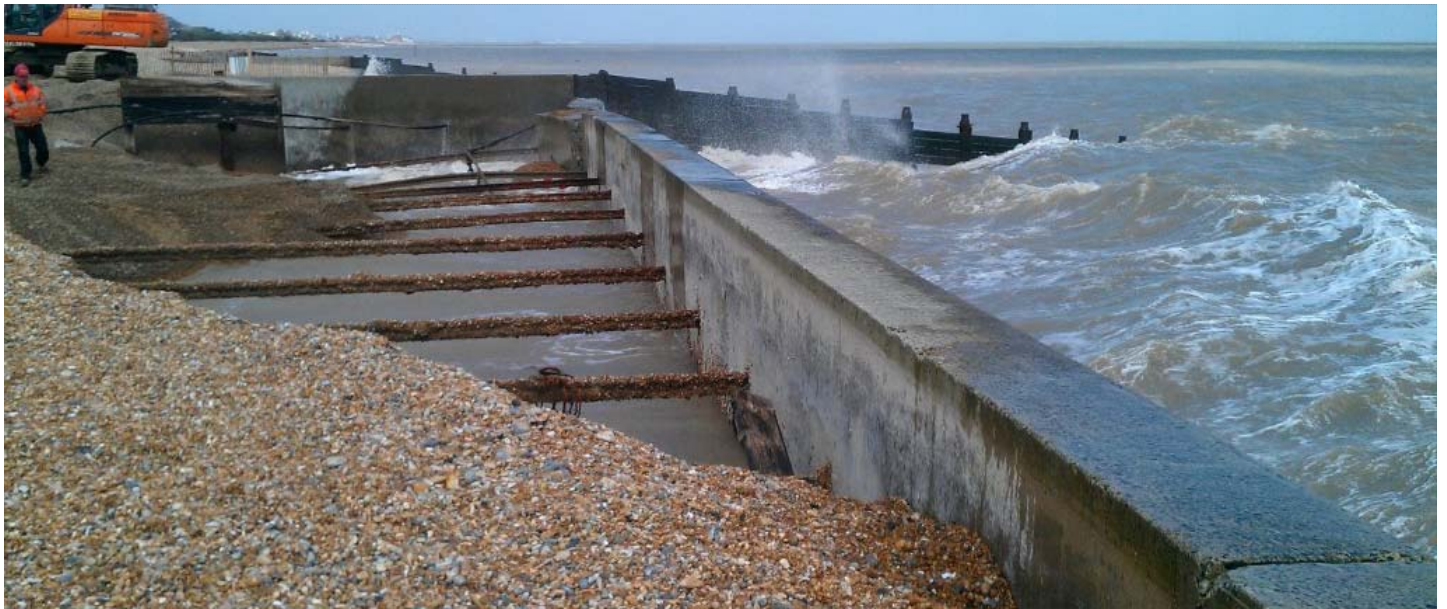
The seawall collapse at Kingsdown required Ovenden Allworks Ltd to undertake emergency repairs to maintain the level of defence in front of the village. The works were critical to upholding the level of defence.

The existing mass concrete wall sits on 2 bearing piles, driven into the chalk approximately 3m below the wall base. The walls are secured from falling seawards with tie rods to mass concrete anchor blocks to the rear of the wall and rely on the mass of shingle behind the wall to prevent the wall falling landwards.

The beach shingle had eroded to a level which allowed shingle to escape under the wall and be washed to sea thus exposing the wall to storm damage
